## 4.3 Landscaped Spaces

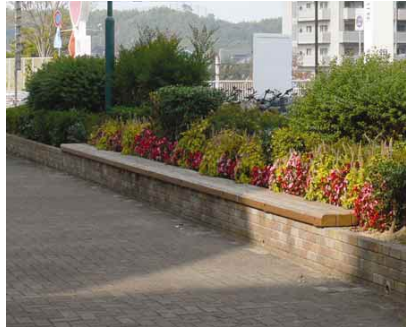
4.3a Buffer planting with colourful blossom and foliage located next to seating bench to facilitate visual enjoyment

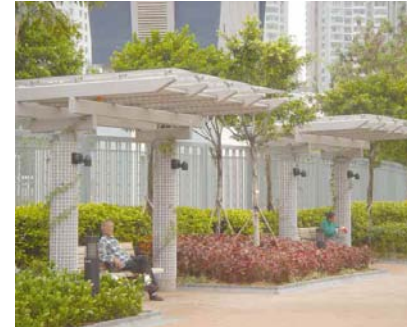
4.3b Accent planting with colourful foliage located near sheltered seats with wheelchair space to draw visual attraction

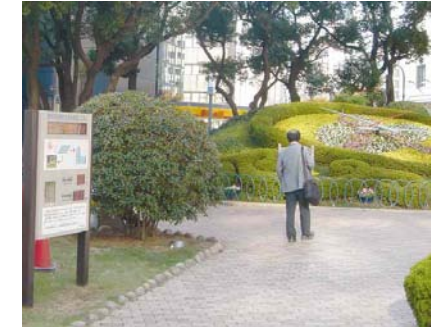
4.3c Flower Clock landscape feature with low-lying herbaceous plants arranged on an inclined plane forming a strong focal point and conveying a sense of time passage

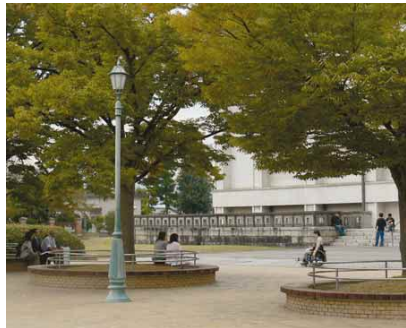
4.3d Thoughtful design that incorporates seating under shade while providing root protection zone for preserved trees

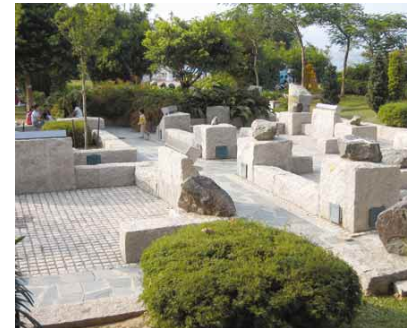
4.3e Landscape theme with accessible outdoor display of mineral rock specimens, tying in with the local history

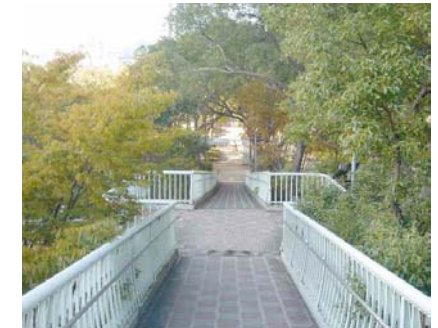
4.3f Spacious landing at ramp intervals allow appreciation of tree canopy and visual accessibility to distant views

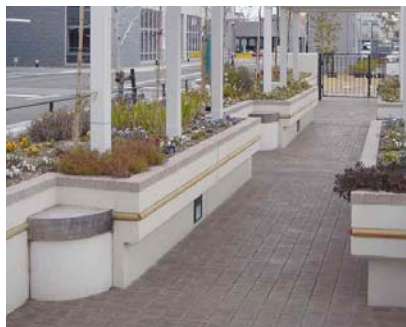
4.3g Specially designed planters for horticultural therapy facilitate appreciation of low-lying herbaceous plants at an accessible height

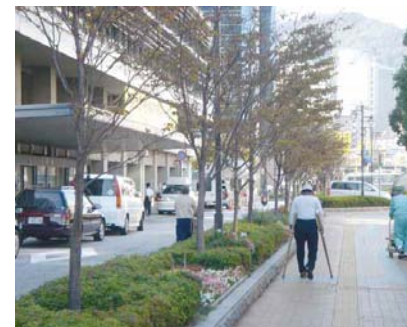
4.3h Street trees planted in appropriate spacing and properly maintained allowing both physical and visual clearance at strategic locations

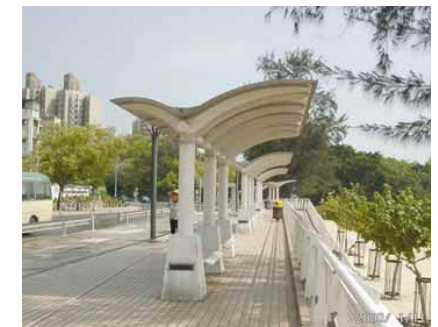
4.3i Sheltered seats strategically located on top of the ramp to provide visual accessibility to the beach and pleasant sea views

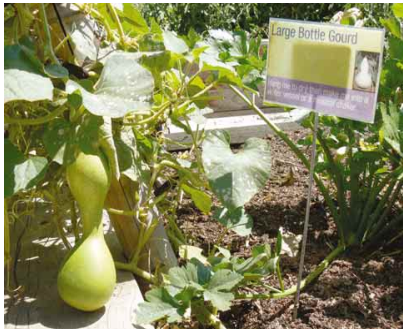
4.3j Special planting features integrated with accessible signage for education purposes

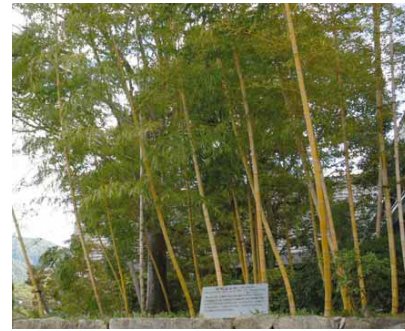
4.3k Large plant labels convey information effectively and facilitate comprehension

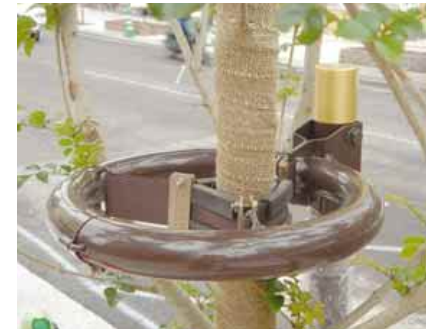
4.3m Staking of roadside trees without any sharp edges or unexpected protrusions

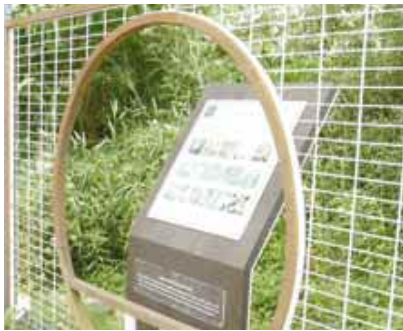
4.3n Interpretive signage integrated into the landscape design

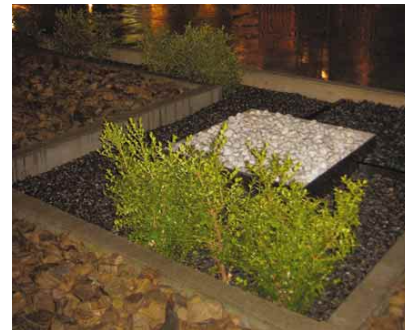
4.3p Thoughtful design using planting and pebbles along edges of a reflective pool to enhance safety at the transitional space

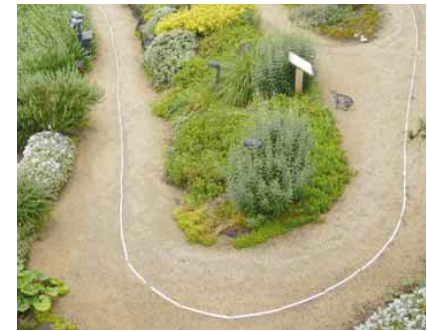
4.3q Tactile clues provided along an accessible ramp that meanders through a landscaped area

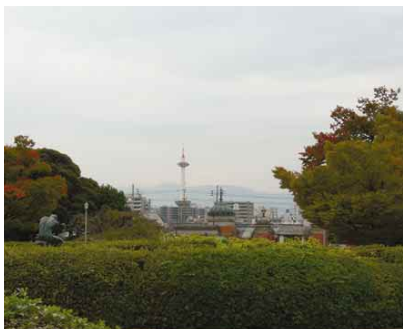
4.3r Good landscape planning integrating vegetation with natural landform to frame views and offer visual accessibility to "borrowed scenery" down the hill

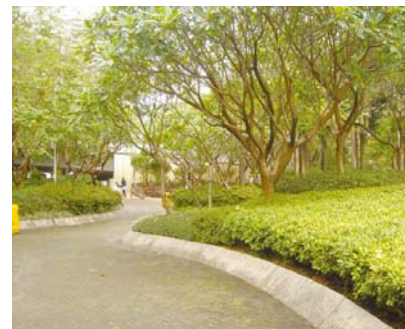
4.3s Low-branching trees planted with appropriate setback from the kerb line to ensure physical clearance on the passageway

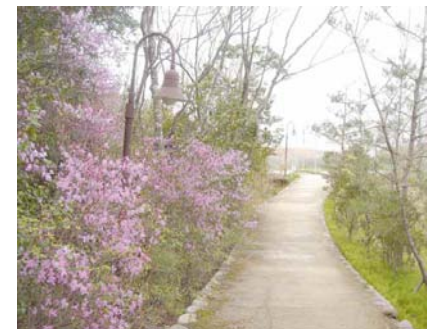
4.3t Well maintained border hedges and flowering shrubs kept at appropriate heights to avoid blocking illumination along the passageway
