Case Studies and Interviews

4.1 Case A and User Feedback

Centrally located in the hub of Causeway Bay, Hong Kong Central Library is a purpose-built library development serving the whole of Hong Kong. The following are the key considerations for access in

Universal Accessibility – Best Practices and Guidelines

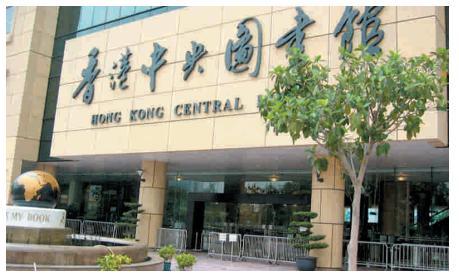
4.1.2.1a) Thoroughfare

During the design planning stage, a pedestrian thoroughfare parallel to Moreton Terrace is incorporated to provide through access between Causeway Road and the Bus Terminus, apart from being one of the access points to the Library. The walkway is made up of series of sloping grounds without steps to enhance barrier free access. A link bridge leading from Victoria Park to the Library main entrance at 1/F deck level is also provided. Lift service is also available for access to the bridge from street level.

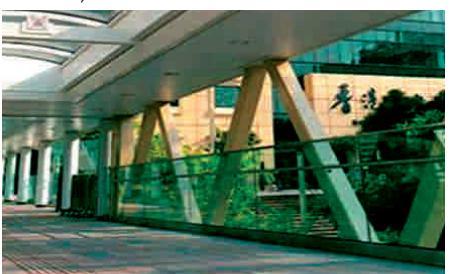
4.1.2.1b) Main Entrance

The main entrance is conveniently located at the centre of the Causeway Road facade, and is prominently marked by the building name sign with the landscaping area and grand staircase

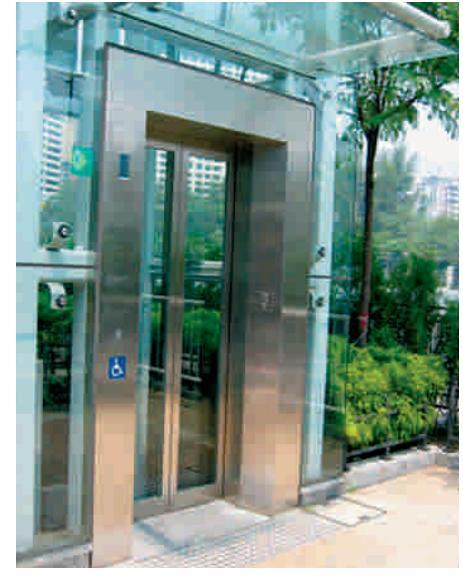
4.1.2.1c) Lift entrance from Victoria Park

The most commonly used entrance/exit is the main entrance at Causeway Road, which is at 1/F deck level, with lift service from Causeway Road. The grand staircase and main entrance are easily identified as the initial access. The side entrance via the external lift tower or escalator can be accessed from Moreton Terrace, which also serves as the vehicular entrance. In addition, the link bridge from the Victoria Park also serves as a convenient access to the Library.

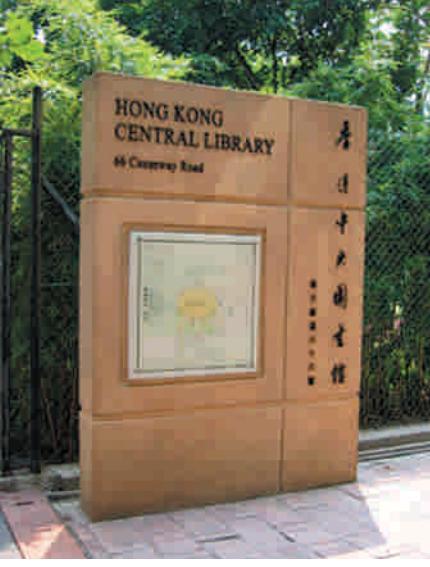
4.1.2.1e) Entrance sign

Freestanding sign posts and wall-mount sign plates are provided from the street level to the deck level informing visitors of the entrances, disabled entrances, major functional facilities, and facilitating wayfinding.

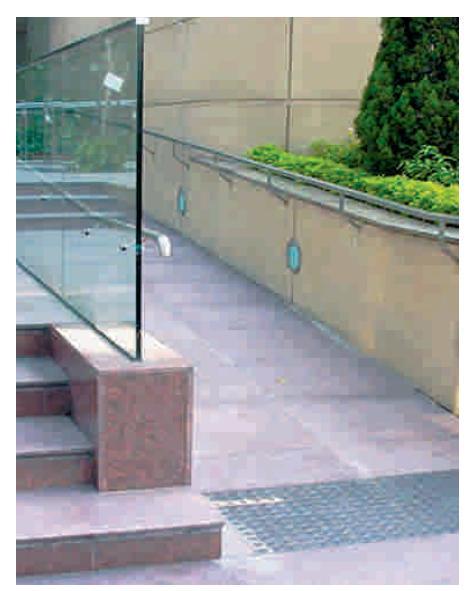
4.1.2.1g) Ramp and stairs

Sloping grounds are used as far as practicable as passageway to facilitate access for all persons. Gentle gradients are used to enhance walking or wheelchair comfort. Ramps are provided with intermediate landings, tactile at top and bottom ends, and footlights. Stairs and steps are provided with contrasting nosing and tactile at top and bottom ends. Integration of these features with the landscaping area also increases the number of people who could share the enjoyment of the landscape beauty. These external surfaces are stable, firm, non-slippery and lie generally in a continuous plane.

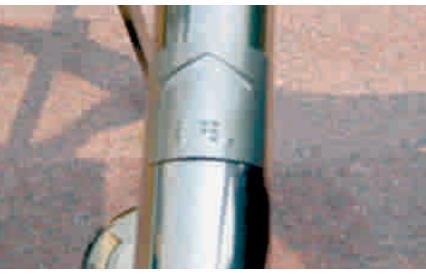
4.1.2.1h) Braille sign at handrail

Mounting heights of handrails for staircases, parapets and ramps are designed to suit people walking and in wheelchairs respectively. Brackets are recessed to form continuous handrails. Braille directional signs are installed at the top and bottom ends of external handrails for direction indication.

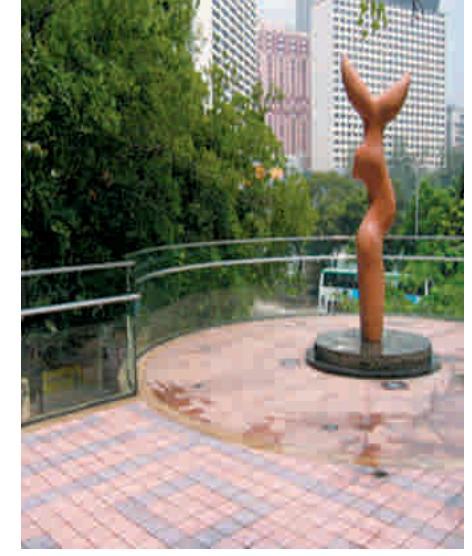
4.1.2.1h) Handrail at parapet

However, the external stainless steel handrails may retain more heat under bright sunlight.

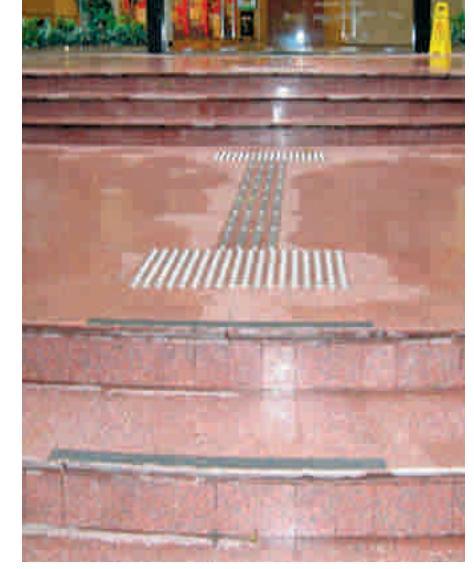
4.1.2.1i) External tactile guide paths

Comprehensive tactile paths both on G/F street level and 1/F deck level are provided to assist wayfinding, leading from various essential areas like Victoria Park, Causeway Road and Bus Terminus. Portions of the external tactile path are also accompanied by footlight flushed with the ground.

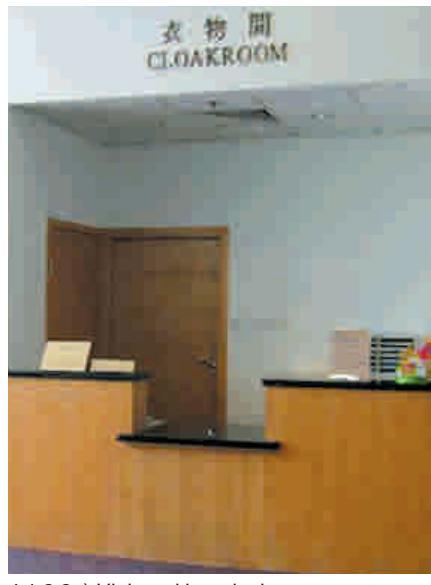
4.1.2.2a) High and low cloakroom counter

Public counters inside the Library include information service counters, book check-out counters, and counters at cloakroom. These counters are generally conveniently located at prominent locations, and are provided with high and low portions. Some are also with protruding counter tops, some with notches for holding crutches, walking sticks and alike.

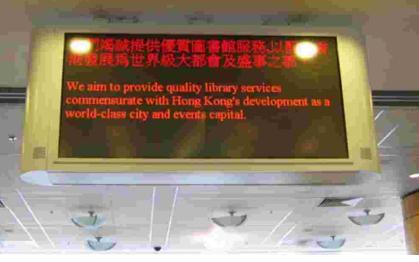
4.1.2.2b) Digital directory

A ceiling hung digital display directory is provided at the main entrance. The size and colour contrast are considered adequate. Induction loop system is available at one borrow/return counter. However, no braille directory is provided.

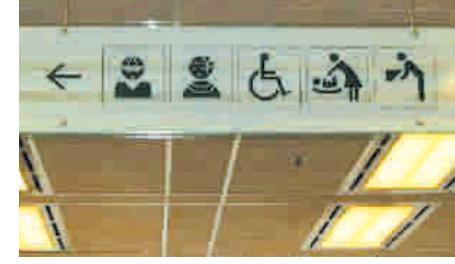
4.1.2.2c) Ceiling hung signage

Floor numbering and facility signs are mostly wall-mounted with contrasting colours for the

signs and the wall surfaces. Direction indication signs designating various functional spaces and facilities are ceiling hung at every floor. Apart from letters, numerals and characters, pictorial symbols are incorporated to facilitate comprehension. Symbols of accessibility are also provided on the same sign. Braille signs are only provided in association with lift installation.

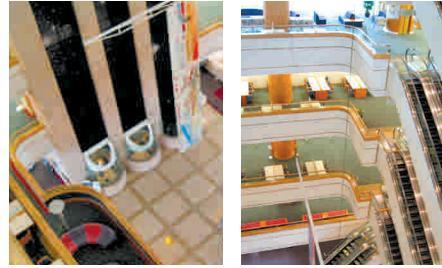
4.1.2.2d) Central atrium with lift zone & escalators

With the central atrium spanning six storeys of the Library, it gives a general impression of orientation upon entry. The atrium is punctuated by passenger lifts at one side and escalators at the other side. These prominent features contribute to a brief mental map for people to find their way.

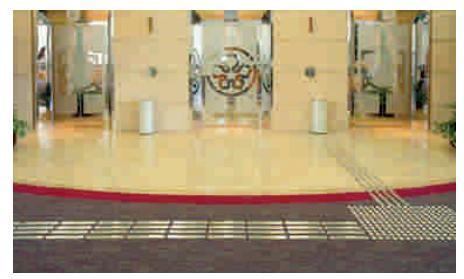
4.1.2.3a)Tactile to lift zone

Tactile is used to alert people to different types of facilities, to hazards and changes in level at top and bottom of ramps, escalators and staircases, and as directional paths leading to major functional areas. Tactile guide paths start from the external access route at Victoria Park, Causeway Road and Bus Terminus to the Library entrances on both G/F and 1/F. Internally, tactile guide paths also lead from various entrances to information counter and lift zone.

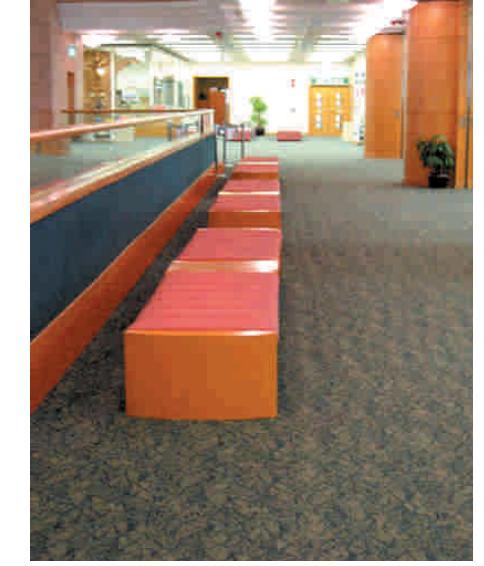
4.1.2.3c) Typical floor passageway

Library is a popular communal facility with anticipated busy traffic. Users are not required to pass through any lobby, corridor and alike. Integrated passageways with the main functional spaces can enhance free movement and minimize conflict due to crowdedness. Obstruction due to any projections is also eliminated with this open plan design.

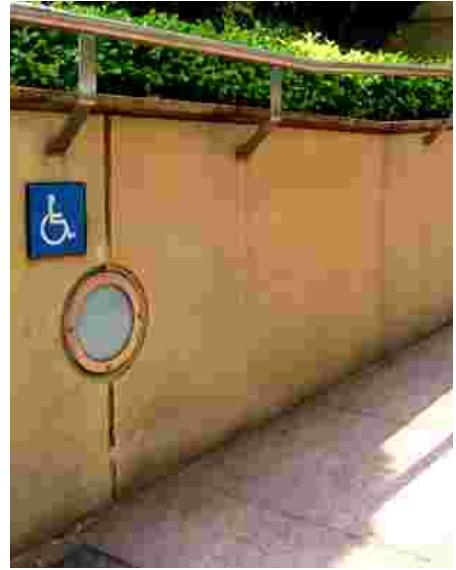
4.1.2.3d) Wall mounted footlight at ramp

natural daylight, which helps to distinguish the floor and wall / vertical surfaces. At each floor level, combined with the use of different colours for floor and wall/parapet surfaces, luminous contrast is achieved to outline the shape of the space. Wall-mounted footlights are provided at ramps for night use.

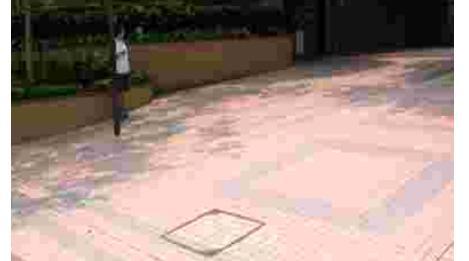
4.1.2.3e) Ground surface finish

The selected external ground surface materials are in general firm, stable, durable, even and slip resistant. Gratings have been avoided along predominant direction of traffic. Drainage is directed to fall towards the edge channels to minimize interruption to the walkway users. The internal floor surface is mainly carpet tiles to maintain good acoustics and slip resistance. Small areas of granite tiles are used at lift and escalator landings and entrance lobby areas. Door mats are installed at entrance doors levelled with the floor.

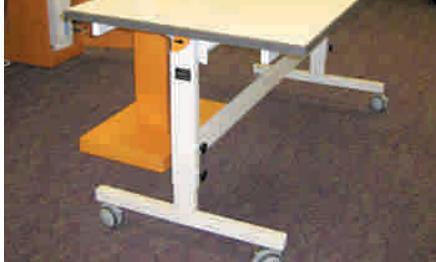
4.1.2.4c) Adjustable height reading table designated for wheelchair users

Priority reading tables with adjustable height are provided to accommodate the armrest of wheelchair. Other facilities like counter tops, computer information kiosks, public pay phones, drinking fountains and hand dryers for wheelchair users are designed with kneespace provision.

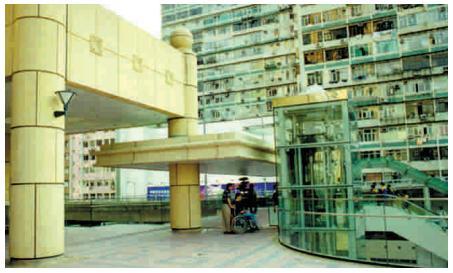
4.1.2.5a) Wheelchair user using lift

Provision of access for the disabled has been included in the lift installation design. Features include wheelchair signs, high and low button panels, braille sign at call buttons, contrasting colour braille floor numbering signs at landing door jambs, audio announcement and visual plasma display information inside the lifts for the visual and hearing impaired.

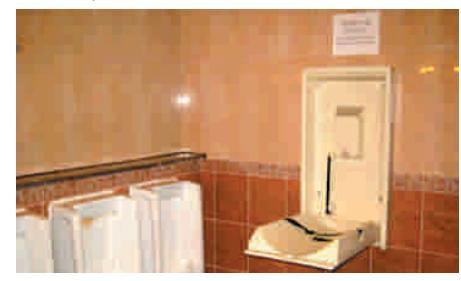
4.1.2.5c) Baby care facility

Rest rooms, sanitary facilities and drinking fountains are available at every floor. Baby care facility is provided inside the disabled toilets. Signage for baby care is only provided at the Children and Toy Library floor. There are a number of good features that cater for the disabled, the elderly and people with babies. Examples include tilted mirror in disabled toilets; disabled water closet with concealed cistern located away from the rear wall to facilitate wheelchair transfer; assisted handrail for one urinal in each male toilet; one recessed hand dryer at high level and a lower protruding one for wheelchair users.

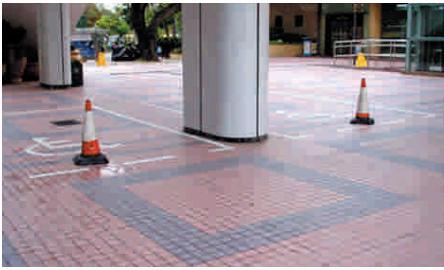
4.1.2.5b) Disabled carparks

Parking is next to the side entrance at Moreton

Terrace. Disabled carparks are designated close to the entrance to Exhibition Hall at G/F and lift tower leading to 1/F main Library entrance.

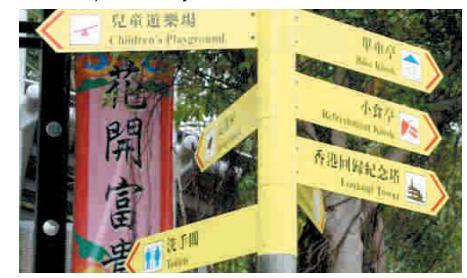
4.2.2.2d) Sign posts are easily identified by the bright colour

Information on sign post is clear and is located throughout the park. Letters, numerals, characters, and pictorial symbols are incorporated to facilitate communication.

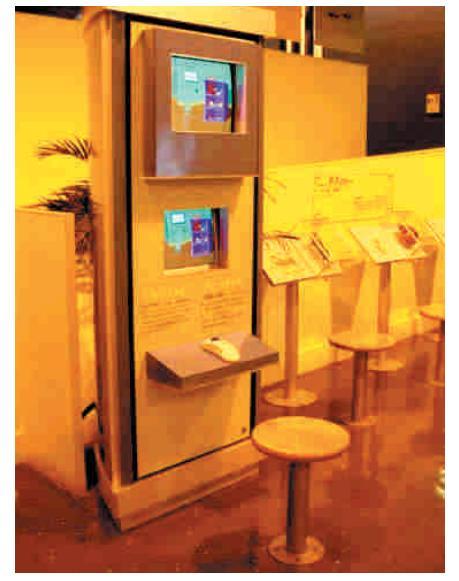
4.2.2.4b) Computer terminals in function area

In visitors centre and Insect House, sufficient space is provided for wheelchair user to access and use the computer information terminals. The screens are installed at two heights so that people sitting and standing can both see the screen.
